Dropped Clamp Keeps Duct Dry

If your M992A2 ammo carrier has a Hatz 2G40 auxiliary power unit (APU), chances are it also has a water problem.

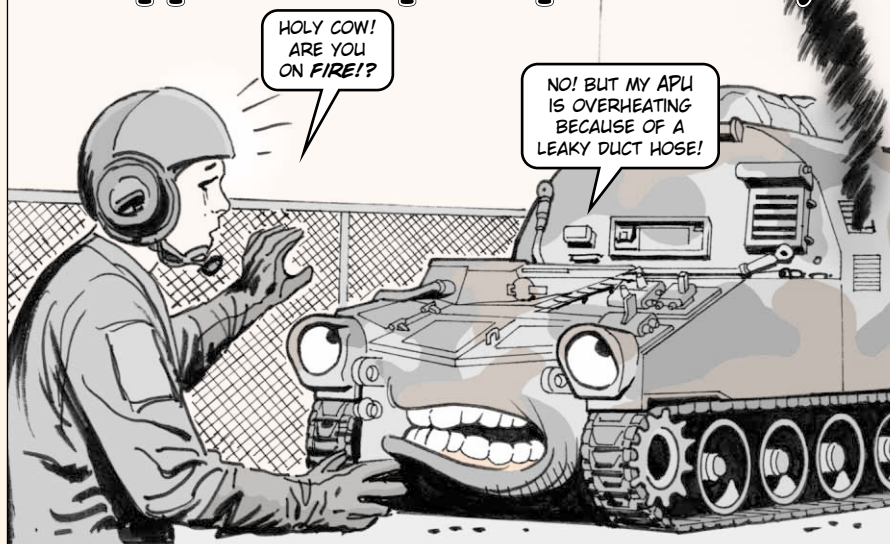
Rain and wash water get into the air duct through the inlet duct. Since the hose is clamped on both ends, the water sits there until the reinforcement wire inside the hose rusts.

Pretty soon, the APU starts overheating because it's pulling hot air through holes in the hose instead of the cooler air it needs from outside.

Stop this damage by removing the hose clamp, NSN 4730-00-908-6293, on the APU side of the air inlet duct. With the clamp gone, any water that gets inside will drain away before rust can set in.

The duct hose is compressed tightly between the APU and inlet duct, so it'll stay in place even without the clamp.
